RE: Follow-up of May 23, 2006 EPA/Hecla Site Inspection

MEMORANDUM

TO: Paul Glader (Hecla Mining Company)
FROM: Doug Gibbs (Monster Engineering Inc.)
DATE: 6/15/06
SUBJECT: **June 1st and 2nd Site Visit – Apex Site**

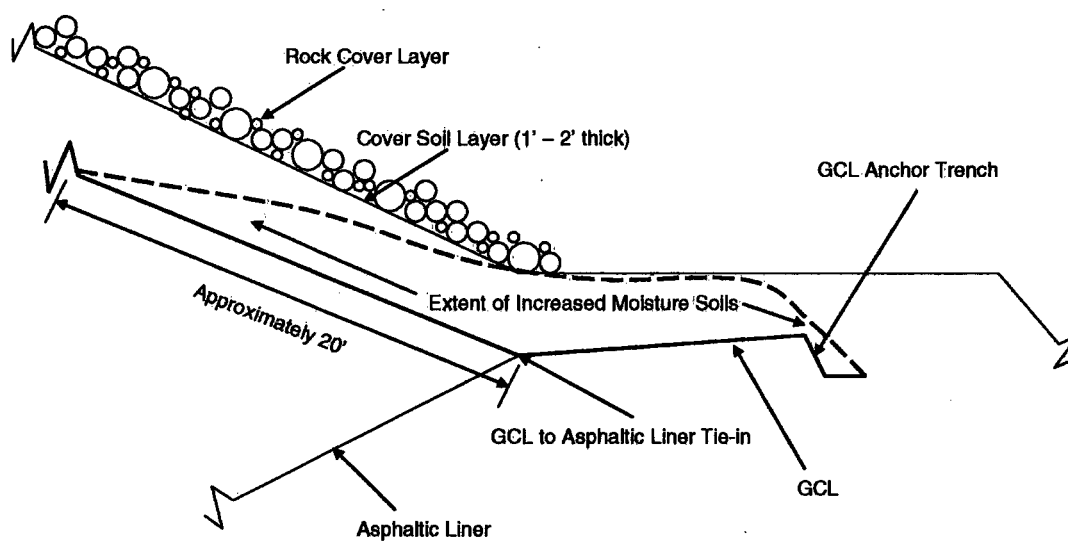
To investigate liner conditions and soil moisture the rock cover was first removed, then the soil cover layer was removed down to the GCL liner as shown in photographs included at the end of this memorandum. The diagram on the following page shows the geometry of the outslope and it's various components.

Not to Scale

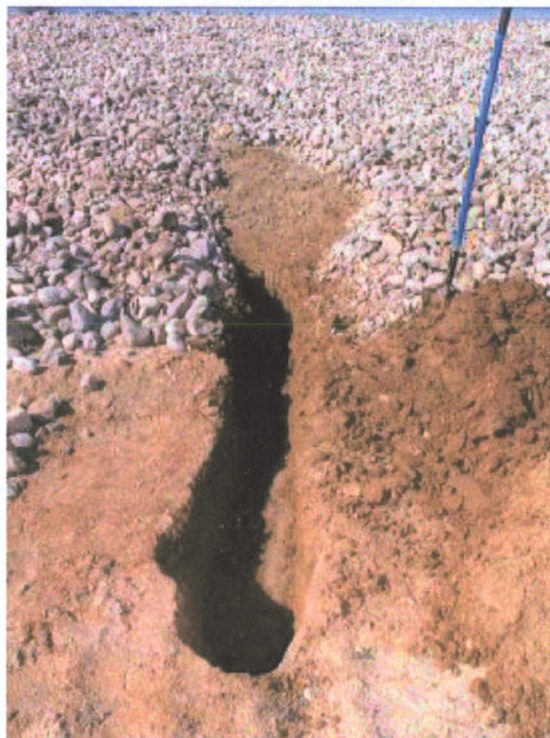
NE Side Excavation

(excavation from bottom of 3:1 to end of GCL as it drops off into the anchor trench at bottom of photo)

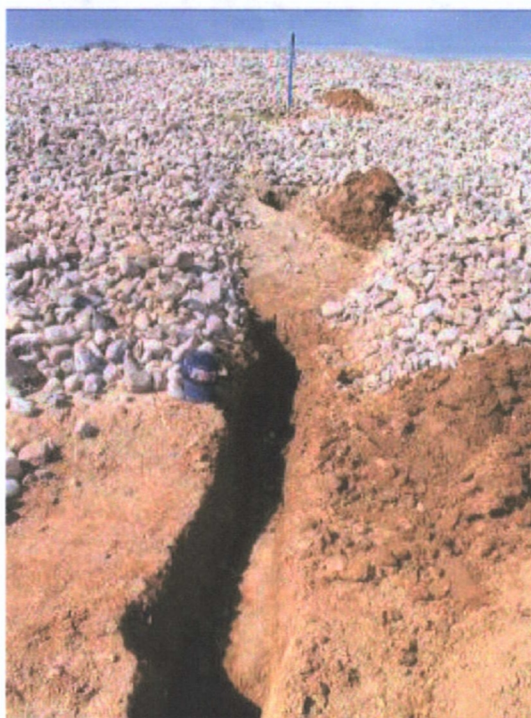
(two excavations further up the 3:1 outslope)

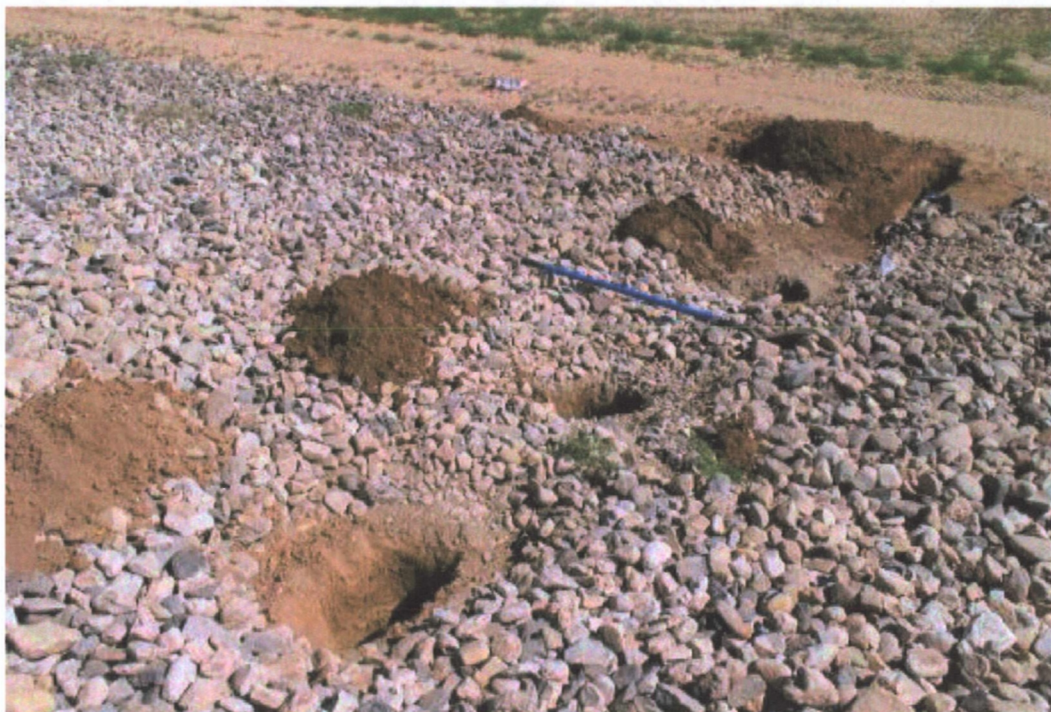
NE Side Excavation
(note increasing soil moisture content near toe of 3:1)

Soil moisture content increased with depth in each test hole. Soil moisture content also increased with proximity to the outslope toe (tie-in of the GCL liner to the old liner), which is also the toe of the rock cover. Soils immediately above the GCL along approximately the lower ten feet of the outslope were nearly saturated as would be expected if the soil cover layer and GCL were working properly.

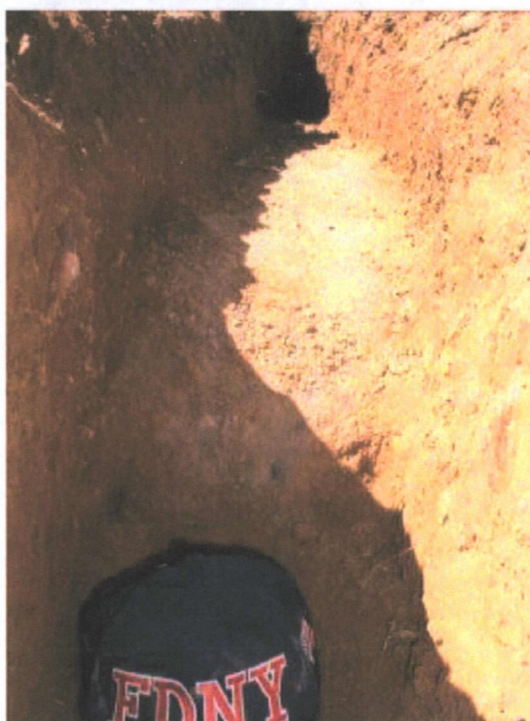
In all excavations, the GCL was intact and there were no signs of damage or leakage through the GCL. There was also no chemical or other waste processing odor associated with any of the materials excavated and inspected. Laboratory results from two soil samples (MEI 1 and MEI 2) collected in this area show that there is no contamination.

(note grey GCL liner in bottom – view into trench towards liner tie-in location)

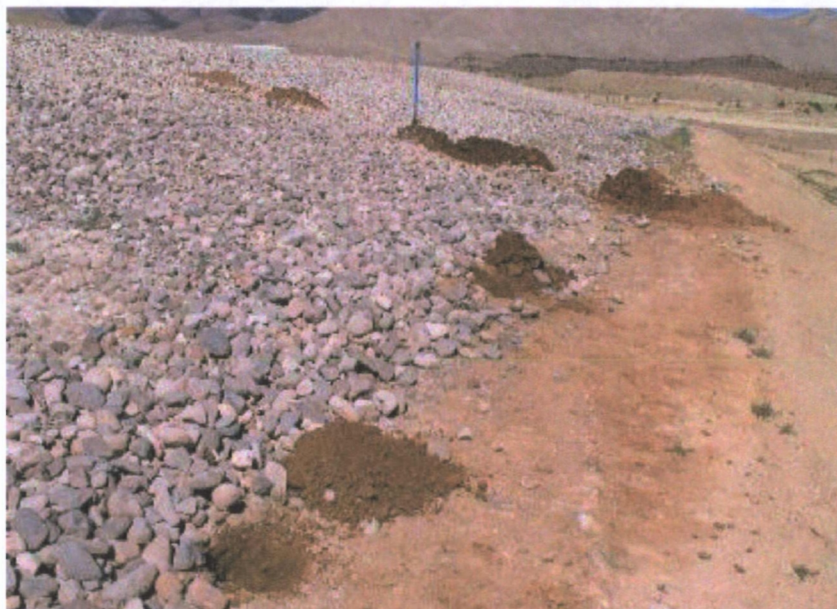
NE Side Excavation

(note slightly darker soil area on bench at toe of slope corresponding to increased soil moisture content)

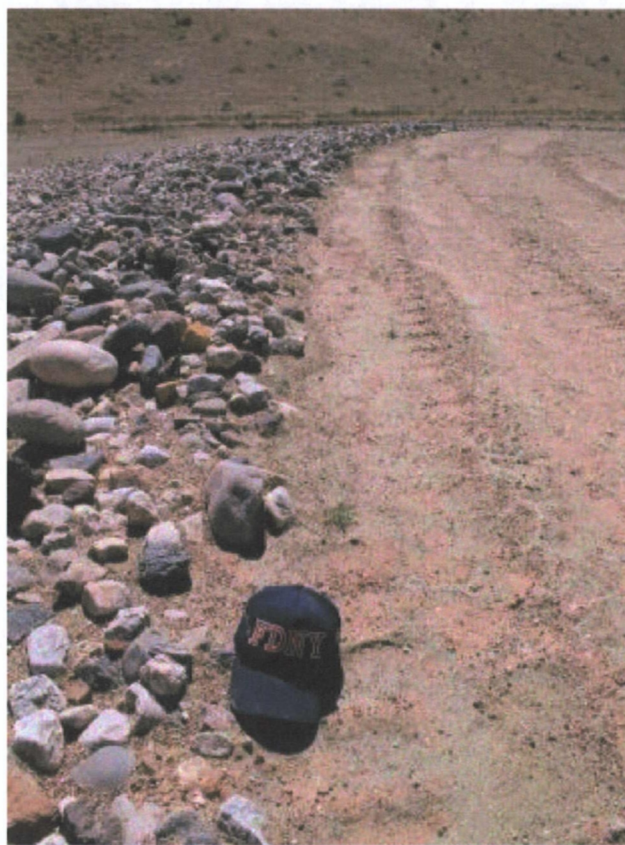
Based on observations of the top surface, the final surface grading and small berm around the edge of the impoundment likely allow for a significant portion of top surface to drain toward and pool at the top of the outslope at this northeast location (see attached photograph). Any runoff pooling in this area would infiltrate into the soil cover layer, then migrate down to the outslope toe on top of the GCL. From that point, depending on final geometry of the tie-in, excess moisture would pool and then migrate away from the impoundment towards the GCL anchor trench. This is apparently what has occurred at the northeast side of the impoundment at the area investigated by MEI.

(top of 3:1 slope directly above investigation area – this was an area of ponding of runoff and flow into the rock cover)

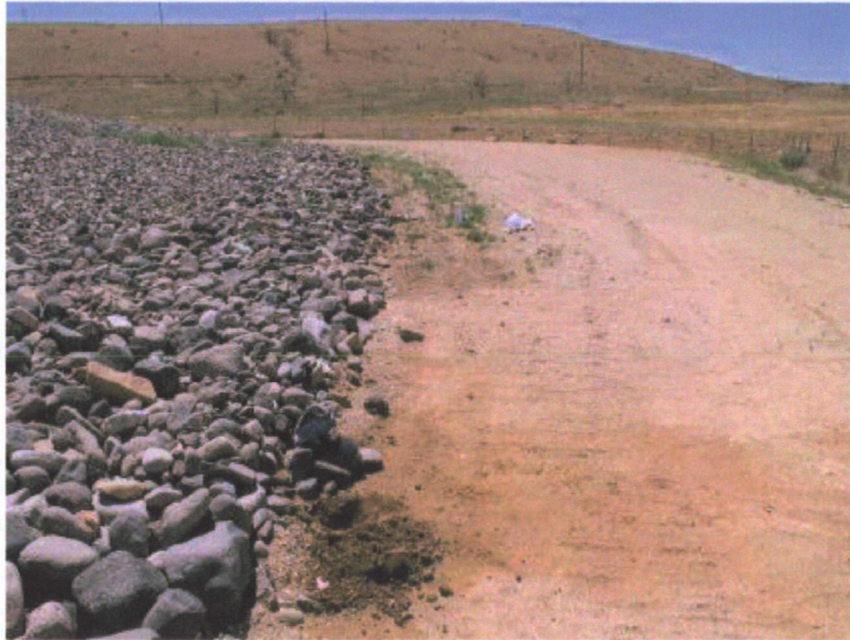
SW Side Excavation

During one of MEI's last site visits during placement of the rock cover, a road grader was parked in this area. As this was a very old, and at that point a broken down piece of equipment, it is a possibility that this piece of equipment leaked or spilled hydraulic or engine oil at this location.

(note two slightly darker soil areas at toe of slope)
